**Characterization of decay in the wooden roof
of the S. Agata church of Ragusa Ibla (southeastern Sicily)
by means of sonic tomography and Resistograph[®] penetration tests**

Abstract We describe the results of a sonic tomography survey and penetration tests carried out inside the S. Agata church of Ragusa Ibla, in southeastern Sicily (Italy). The purpose of this work was to evaluate the extent of decay in some of the ancient wooden trusses of the nave's roof, in view of possible strengthening interventions. Sonic tomography is entirely non-invasive and is suitable to investigate large portions of a structure, although in a qualitative way, while penetration tests are little invasive, point measurements that enable high-resolution detection of wood decay and cracks. We combined the two techniques to investigate the internal condition of 4 trusses that looked most deteriorated at a preliminary visual inspection. Results showed that decays mainly occur in portions of the timbers that are next to the walls, due to rainwater infiltration, and on the side facing the rear end of the nave; in general, chords have worse mechanical properties than rafters.

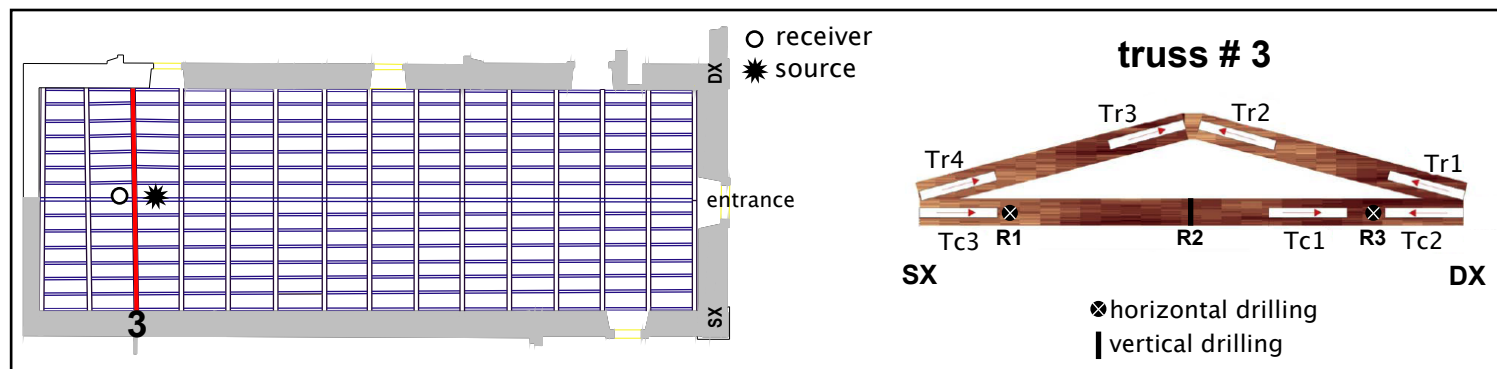
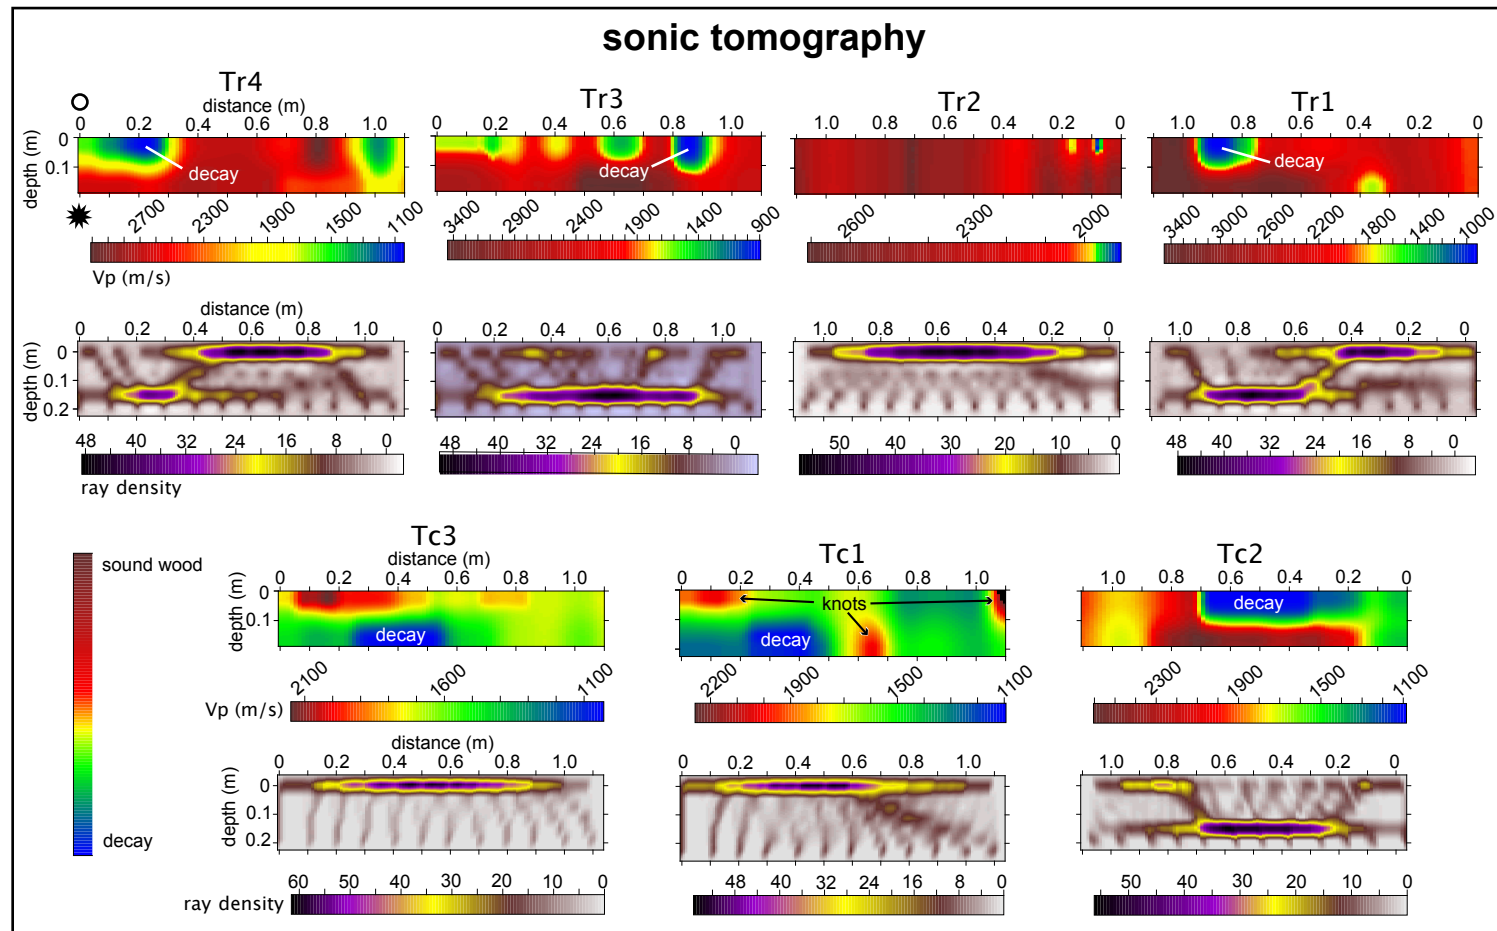
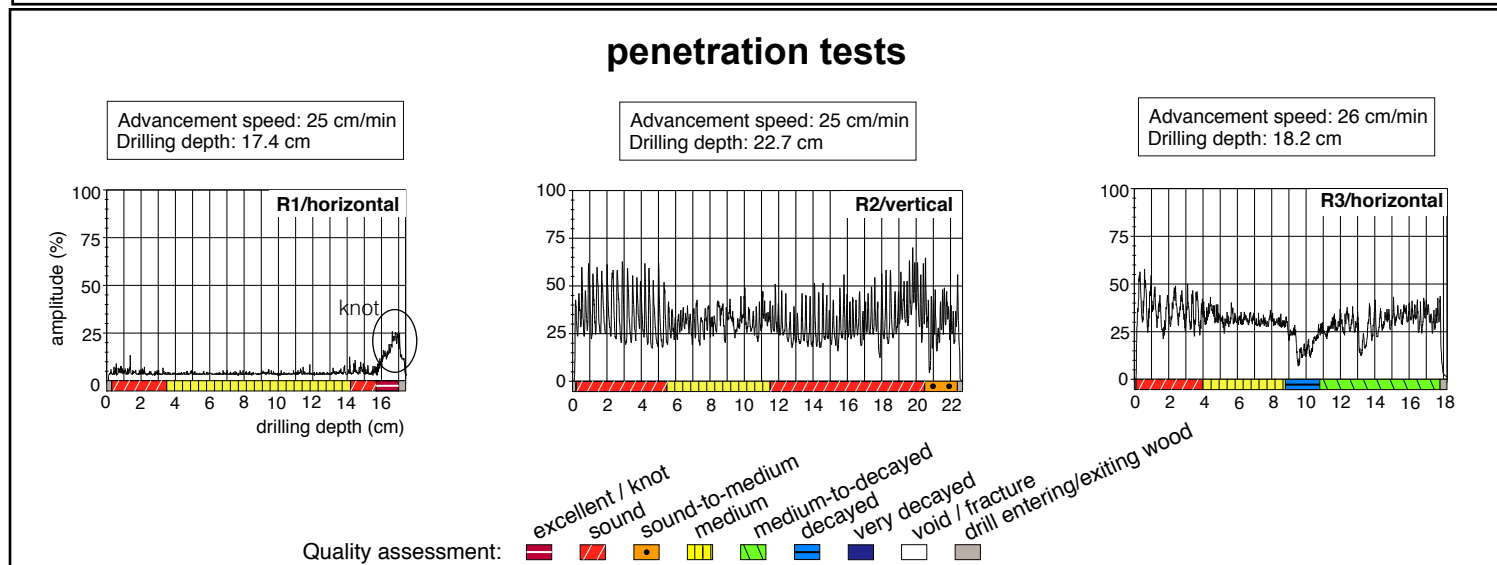
In the truss # 3 (Figure 4) sonic velocity ranges from 900 to 3,400 m/s along the rafters (Tr1-Tr4) and from 1,000 to 2,600 m/s along the chord (Tc1-Tc3), this last characterized by

the largest low-velocity anomalies. In the rafters, V_p is predominantly higher than 2,000 m/s (red to brown), revealing the presence of sound wood, with sparse low velocity areas (blue) indicating the presence of decay in the first centimeters of depth. The high-velocity spots imaged in Tc1 are interpreted with the presence of knots.

Since the chord exhibited the worse mechanical conditions, penetration tests were performed on this element only. The drilling sensitivity level, tentatively chosen for a "hard" wood type in the first measurement R1, was set to a "soft" wood type in the remaining tests. R1 was drilled next to the right end of Tc3 that is characterized by intermediate V_p values. Consistently, this test displays a medium-quality wood (yellow bar) for most of the path. The highest drilling resistance between 15.7 and 17.0 cm is due to the presence of a knot. The test R2, drilled vertically in the middle of the chord, in a point that looked intact at the surface, confirmed the presence of a good-to-medium quality wood. Along R3 wood is variable from sound to decayed.

Figure 4 Upper panel: (left) plan of the S. Agata church with the truss under test highlighted in red; the position of sources and receivers used for tomography following the configuration of Fig. 2d is also indicated; (right) truss outline with the position of penetration tests and tomography profiles (the right- or leftward sense of acquisition is due to logistic reasons). Middle panel: sonic tomograms and corresponding ray density diagrams. Tomograms image horizontal slices of the timbers with the y-axis (depth) increasing toward the church's entrance. They illustrate wood quality with different colors: brown to red indicate areas where waves travel relatively fast, corresponding to sound wood; blue indicates areas where waves travel relatively slow, corresponding to decay or defects; green indicates transitional properties of wood between fast and slow wave transmission. The ray density diagrams indicate the number of rays sampling each cell of the velocity model. Lower panel: profiles of resistance to penetration vs. drilling depth. Colored bars along the x-axis indicate wood quality. Depth varies between 16 and 24 cm depending on the thickness of the timber in the drilling direction. The horizontal tests are drilled toward the entrance of the church; the vertical test R2 is drilled upwards. The resistogram R1 was obtained using a low drilling sensitivity, raised in the following tests.

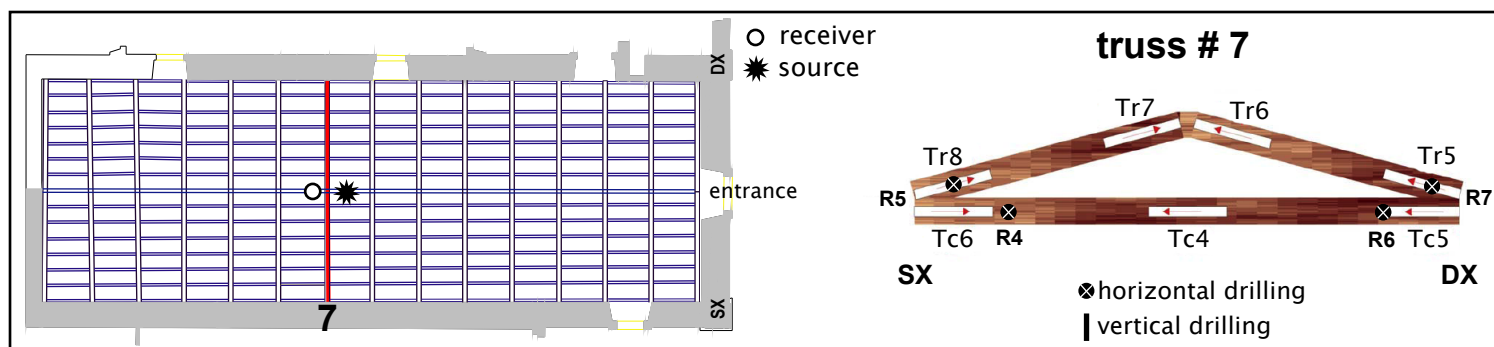
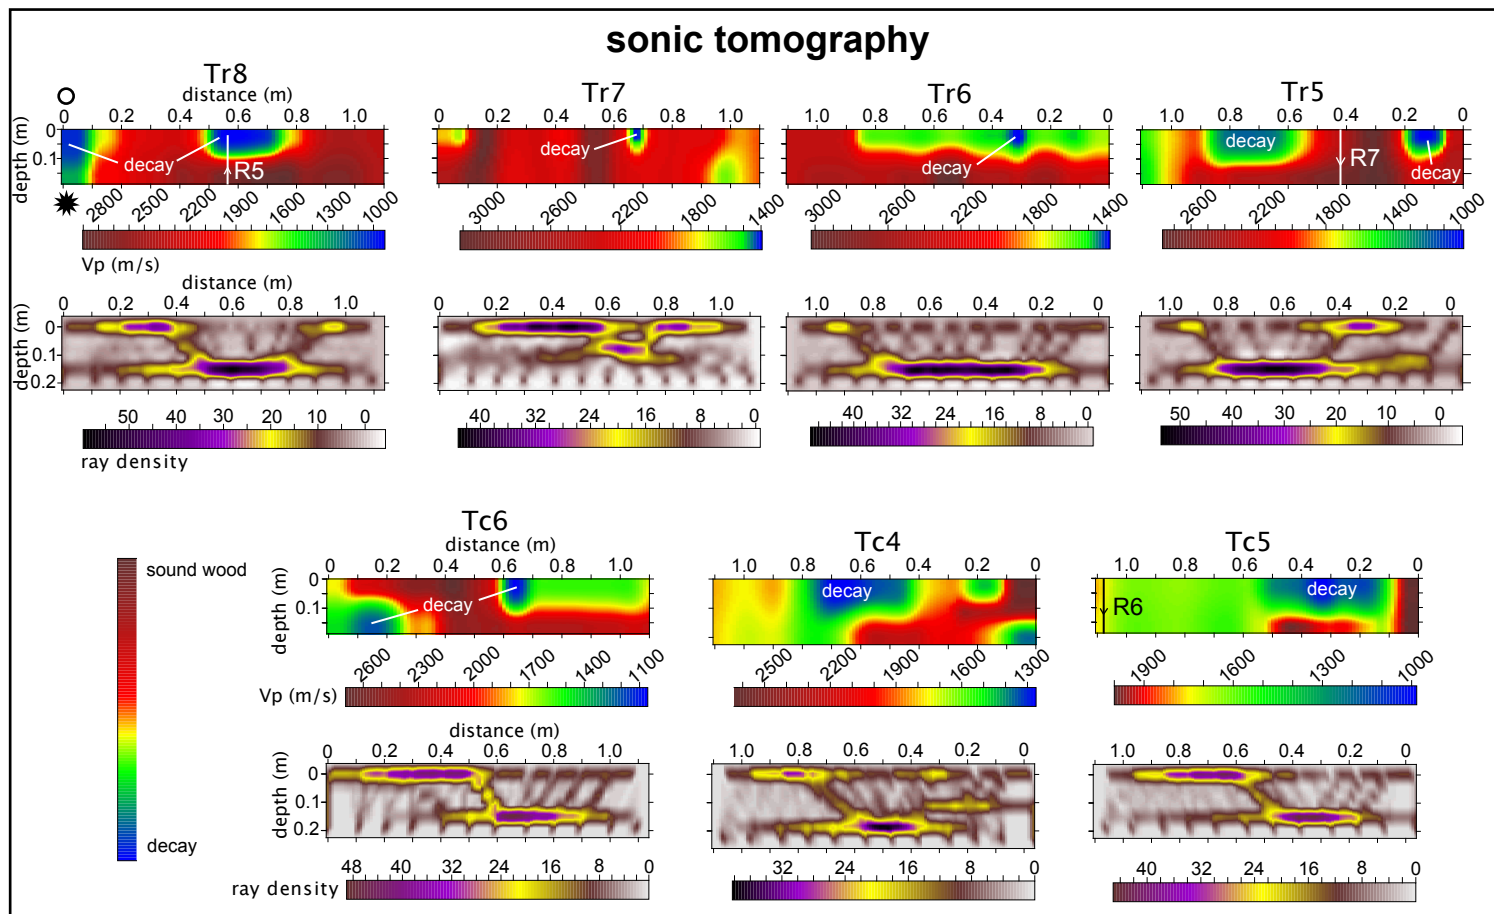
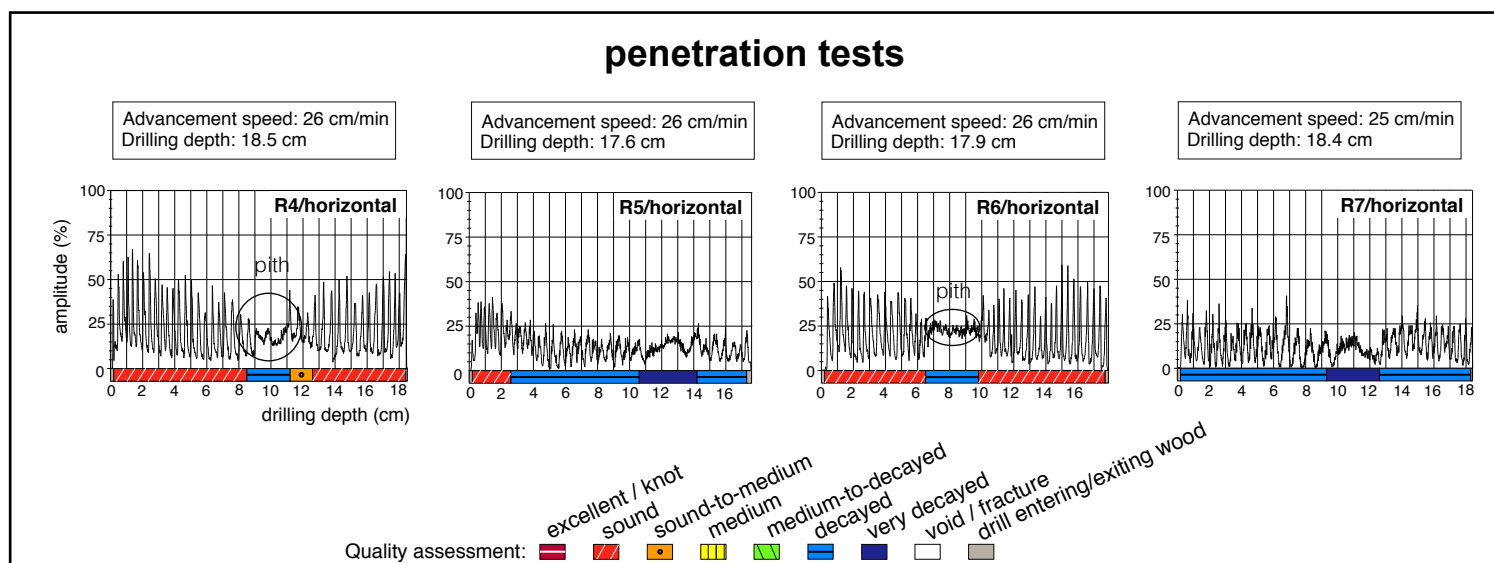
In the truss # 7 sonic velocity is lower and deteriorations are larger in the chord than in the rafters (Figure 5), as in the truss # 3. Sound wood is drilled in the chord along R4 and R6, this last crossing the tomogram Tc5 in a point of almost absent ray coverage. R4 and R6 intersected the pith area between 8.5 and 11.2 cm and 6.5 and 9.8 cm, respectively. Pith is a spongy tissue offering a lower resistance to drilling with respect to adjacent areas; for such reason the pith portion detected by R4 and R6 was assessed erroneously as "decayed wood" by the Resistograph®.

R5 and R7 tested the rafters across the tomography profiles Tr8 and Tr5, respectively. R5 detected a wood quality variable from sound to decayed, in agreement with the velocity imaged in Tr8; in contrast, the low amplitude displayed by R7 is not consistent with the high velocity values imaged in Tr5.

Figure 5 As in Figure 4, except that results refer to truss # 7. In the middle panel, lines crossing the tomograms along-depth indicate horizontal drillings (orientation is given by the arrow).

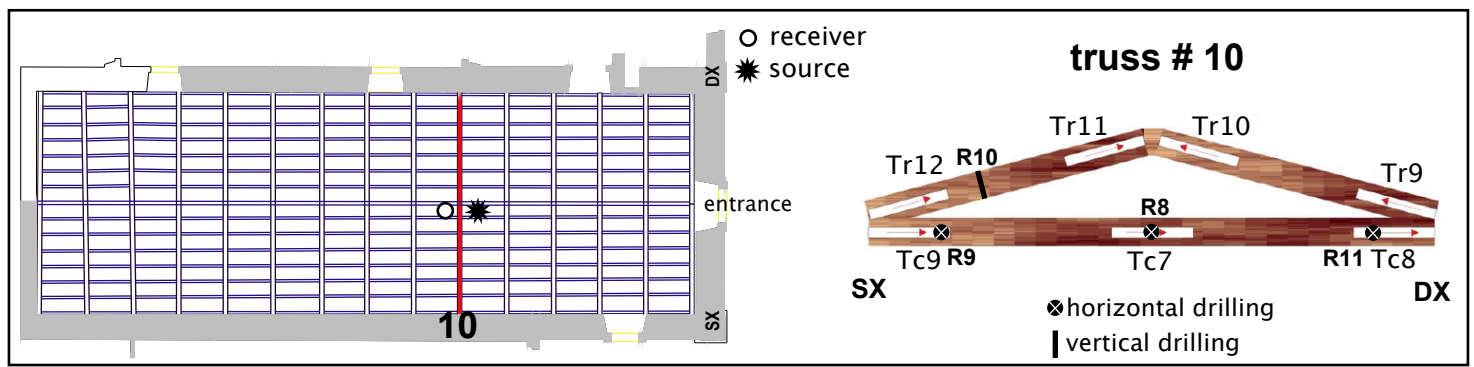
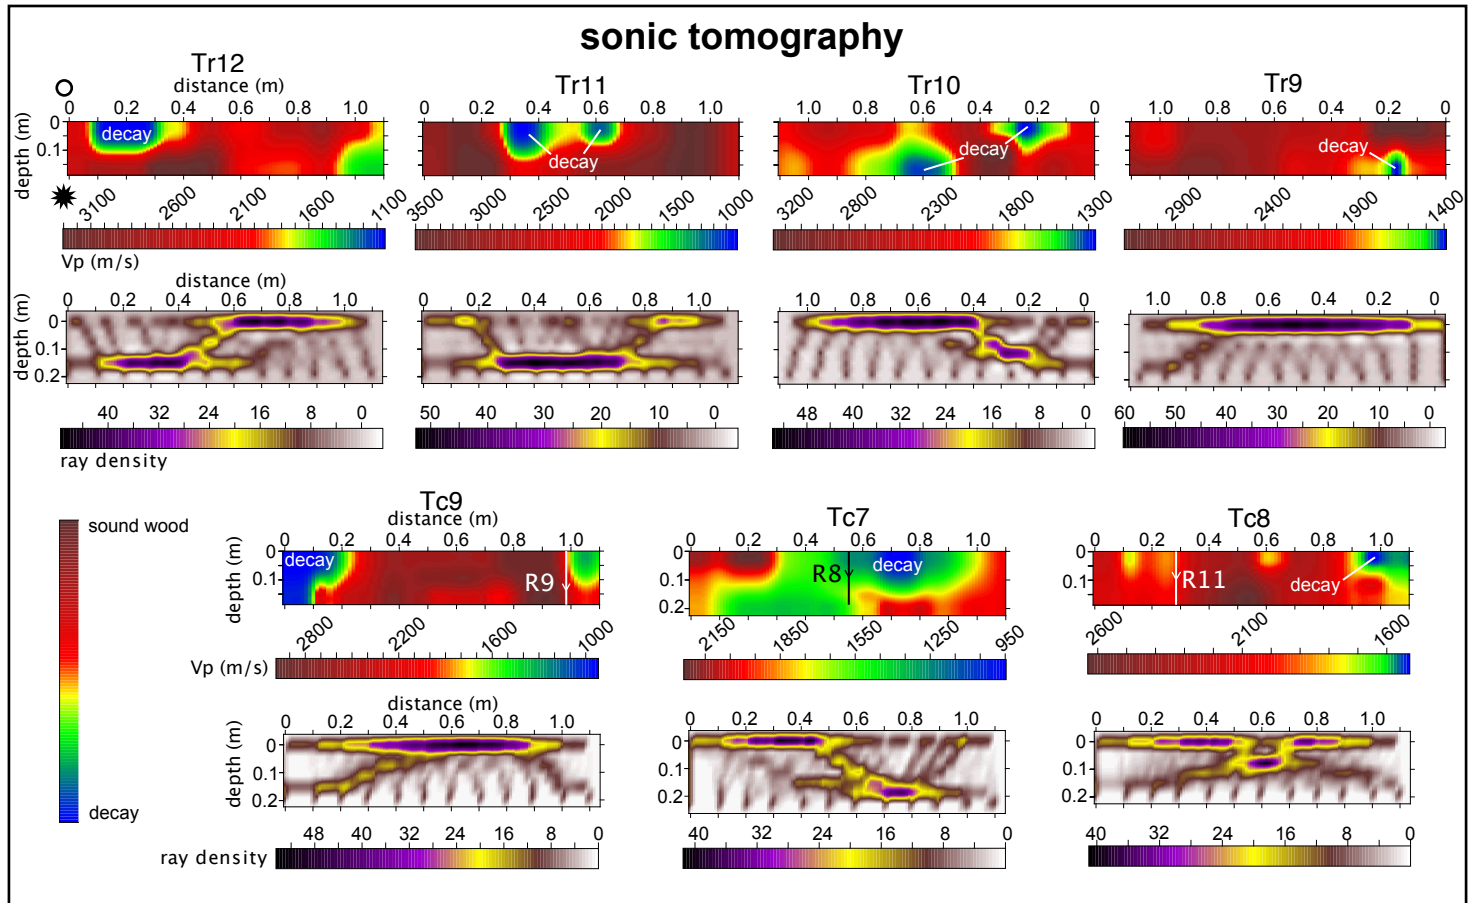
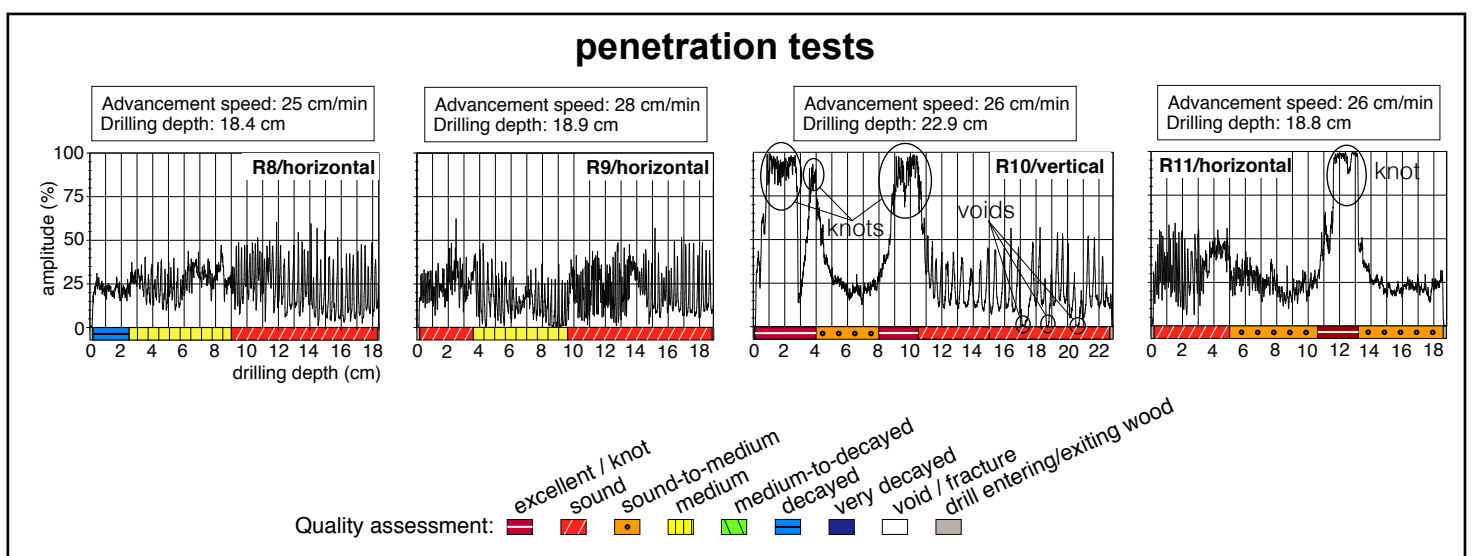
The chord of the truss # 10 (Figure 6) has better mechanical conditions than trusses # 3 and

7, but velocity is still lower than in the rafters. Deteriorations are present at the ends of the chord (tomograms Tc8 and Tc9).

Penetration tests R8, R9 and R11 were drilled horizontally into the chord, crossing three tomography sections. Results are remarkably consistent: R9 and R11 detected good-quality wood across areas of high velocity in Tc9 and Tc8, respectively, while R8 detected a variable quality in the middle of the chord, as imaged in Tc7. The 1-cm knot drilled by R11 was not resolved in the tomography image. Across the left rafter, R10 drilled a good-quality wood with centimetric portions of maximum resistance to drillings (knots). Few micro-voids were picked out next to the upper side of the timber (at 17.0, 18.6 and 20.5 cm).

Figure 6 As in Figure 4, except that results refer to truss # 10. In the middle panel, lines crossing the tomograms along-depth indicate horizontal drillings (orientation is given by the arrow); the vertical test R10 is drilled upwards.

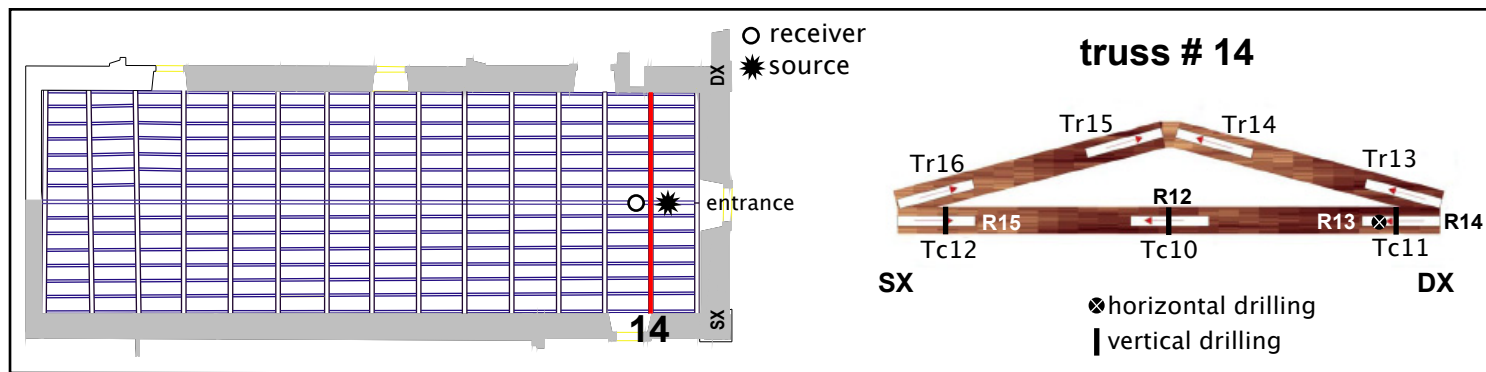
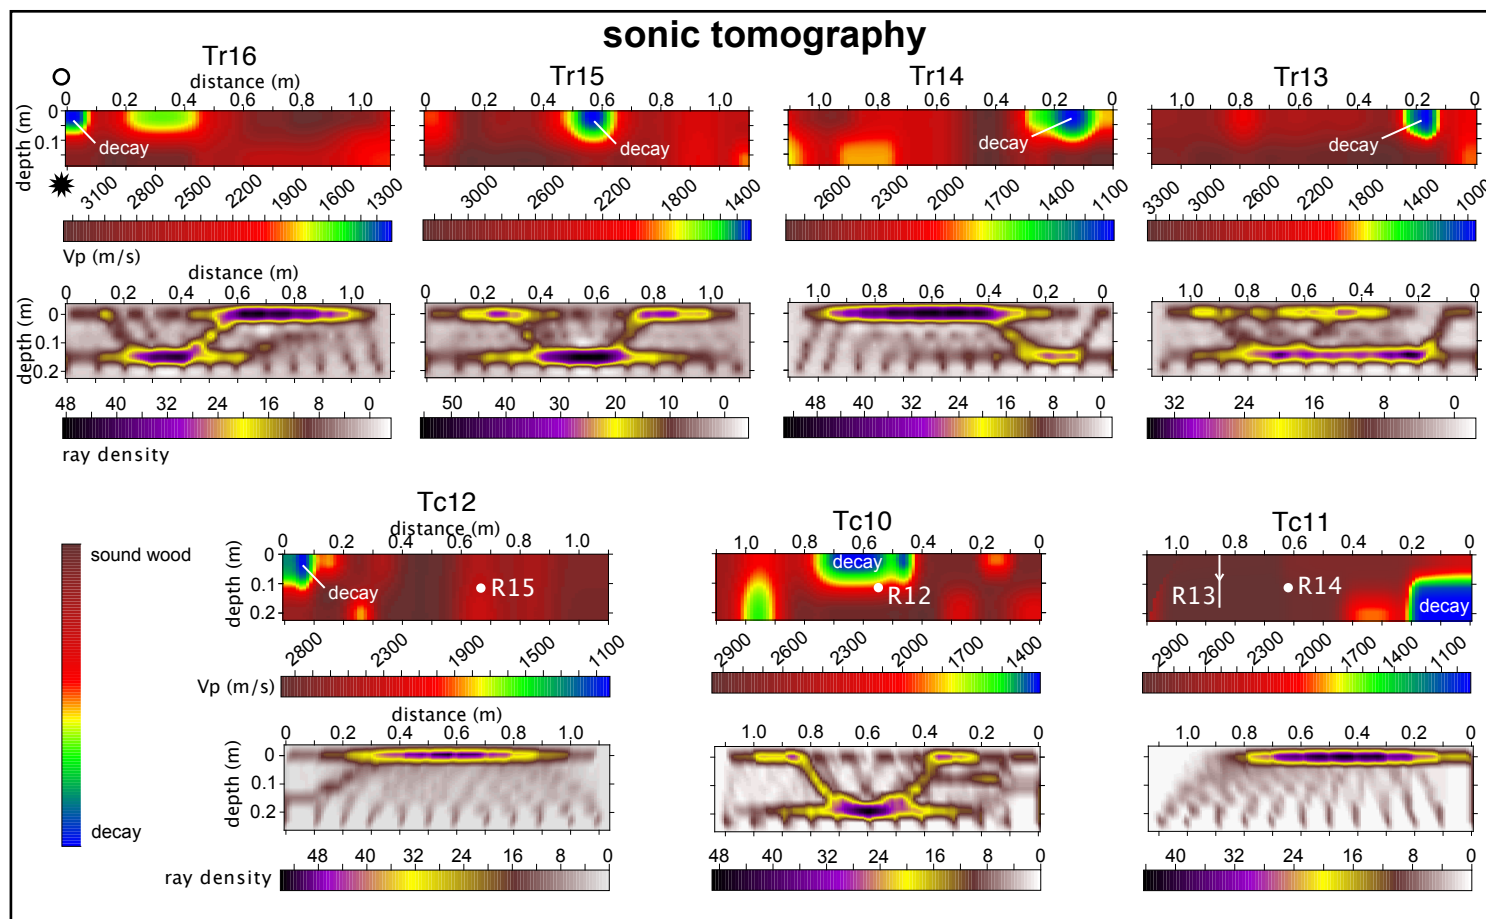
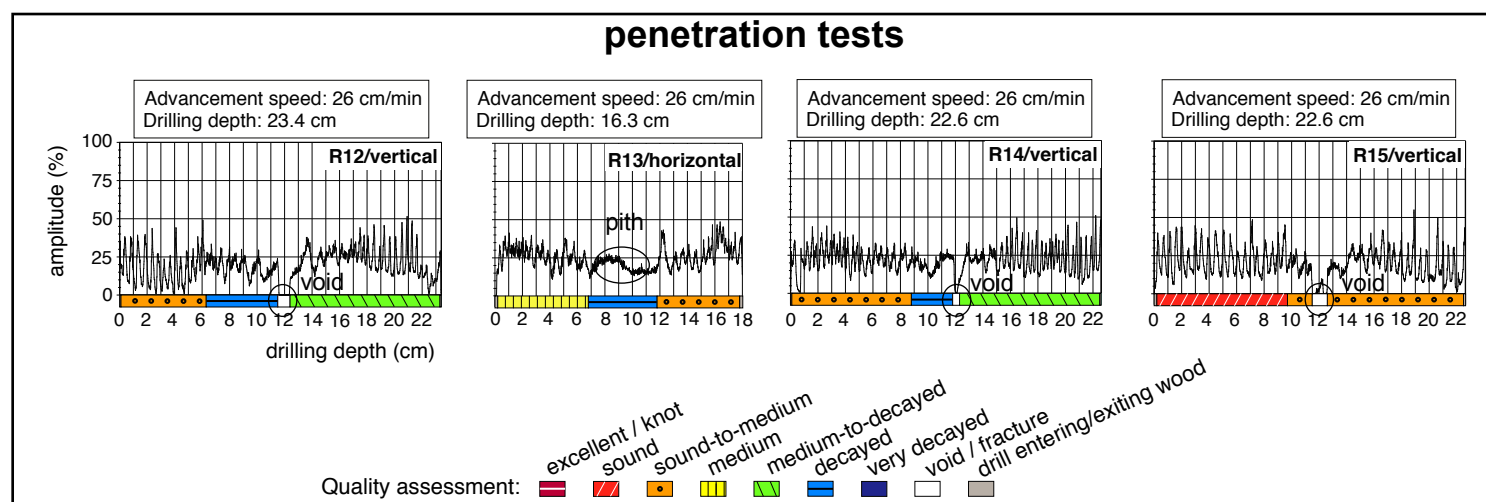
Truss # 14 is mostly characterized by high velocity with small decayed areas in the upper 10 cm of the sections (Figure 7). The larger low-velocity anomaly imaged at the right end of the chord (Tc11) is poorly constrained. Three vertical drillings, equally spaced along the chord from one end to the other, detected a small cavity (few mm to 1 cm) at the same depth; this is suggestive of a linear continuous feature, possibly a microcrack, extending along the entire length of the timber.

Figure 7 As in Figure 4, except that results refer to truss # 14. In the middle panel, lines crossing the tomograms along-depth indicate horizontal drillings (orientation is given by the arrow); circles indicate the position of vertical drillings, drilled upwards.
